**Flood Control Project Maintenance
Levee Inspections**

Fall 2008 Levee Maintenance Deficiency Summary Report

San Joaquin River Basin

Reclamation District No. 2089

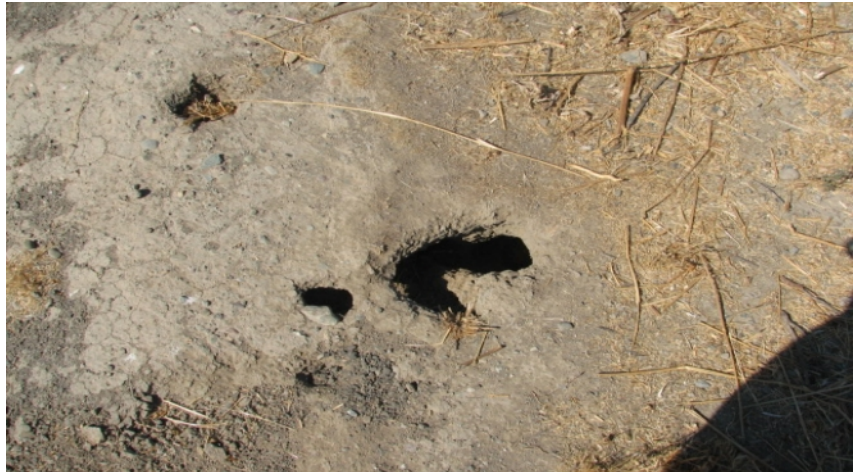
Levee Mile Report Line	9
Start Levee Mile	0.40
End Levee Mile	0.40
Location	
Category	Earthen Levee
Item	Animal Control
RD 2089: Large/deep animal burrow discovered on WS. Numerous others are present throughout this district.

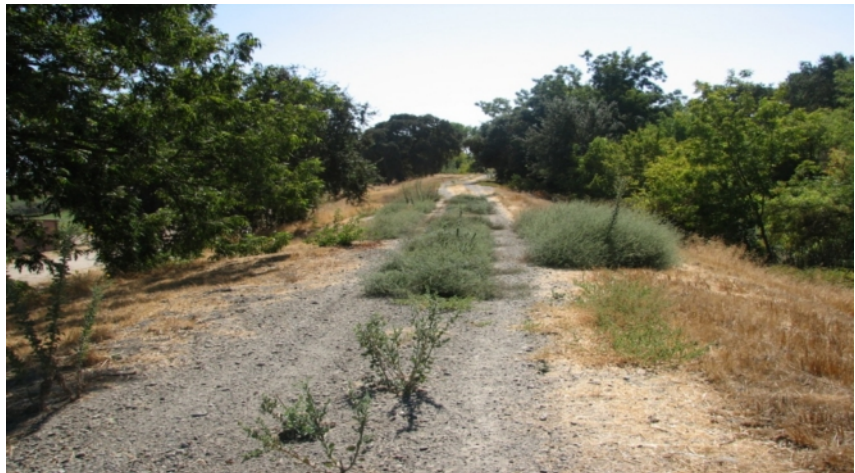
Levee Mile Report Line	21
Start Levee Mile	1.24
End Levee Mile	1.40
Location	
Category	Earthen Levee
Item	Crown Surface / Depressions / Rutting
RD 2089: Crown roadway needs improvements.
